TE 87819

Title: Ad-hoc fire test on a Metaloterm AT chimney system when subjected to an internal fire.

Client: Climatec Chimney Products,
Water House,
Ruxley Manor,
Maidstone Road,
Sidcup,
Kent,
DA14 5BQ.

Date: 2 August 1996

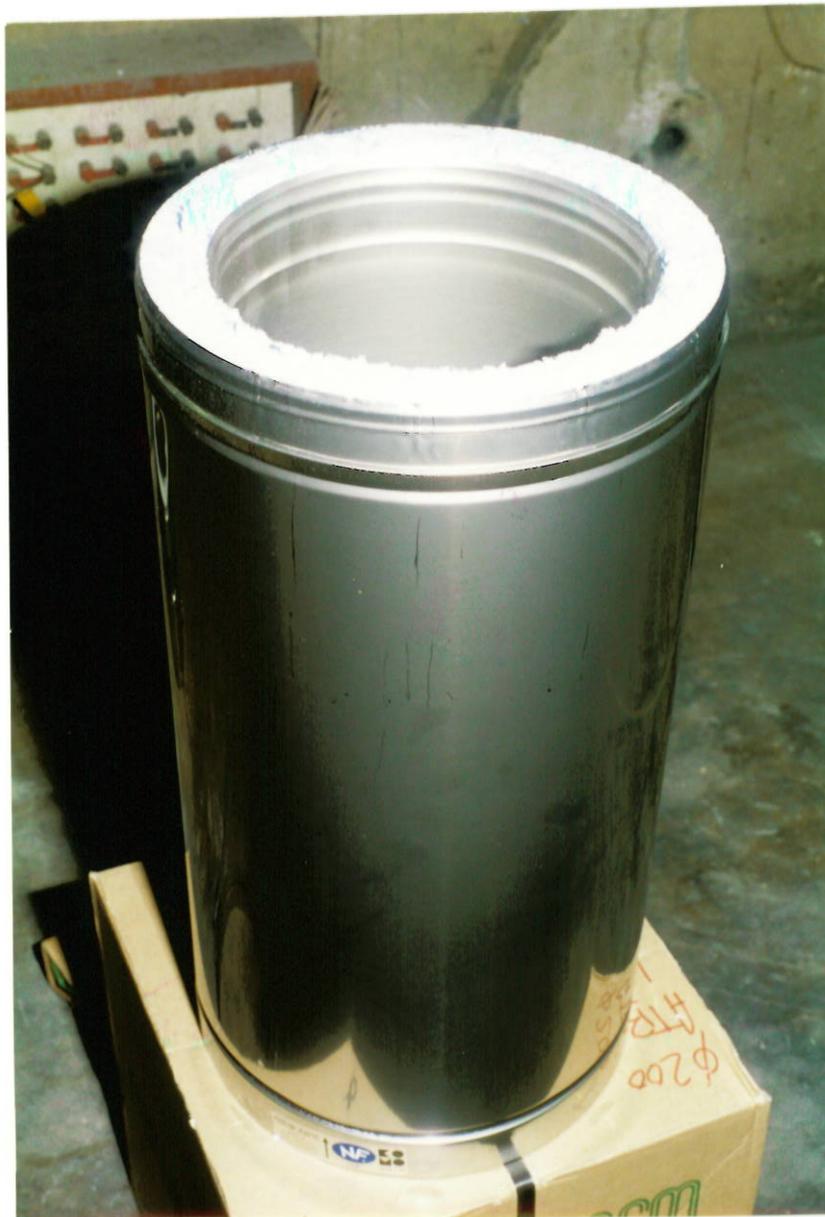
Plate 1 Metaloterm AT100 chimney section showing flush insulation at one end

Each chimney section was double walled, with a 200mm internal diameter and a 37.5mm insulated cavity. The external diameter was 275mm. The inner wall was manufactured from 0.4mm-thick 316 stainless steel and the outer wall from 0.4mm-thick 304 stainless steel. The seams in both walls were continuously welded. The cavity was filled with white coloured insulation with blue flecks. It was stated by the sponsor to be Insulfrax mineral fibre with a density of 160kg/m³. At one end of each section the insulation was rebated by 30mm and the outer casing had a series of barbs pressed into it. At the other end the insulation was flush with the casing and the outer casing had an arrangement of ridges rolled around it. The chimney sections are shown in Plates 1 and 2.

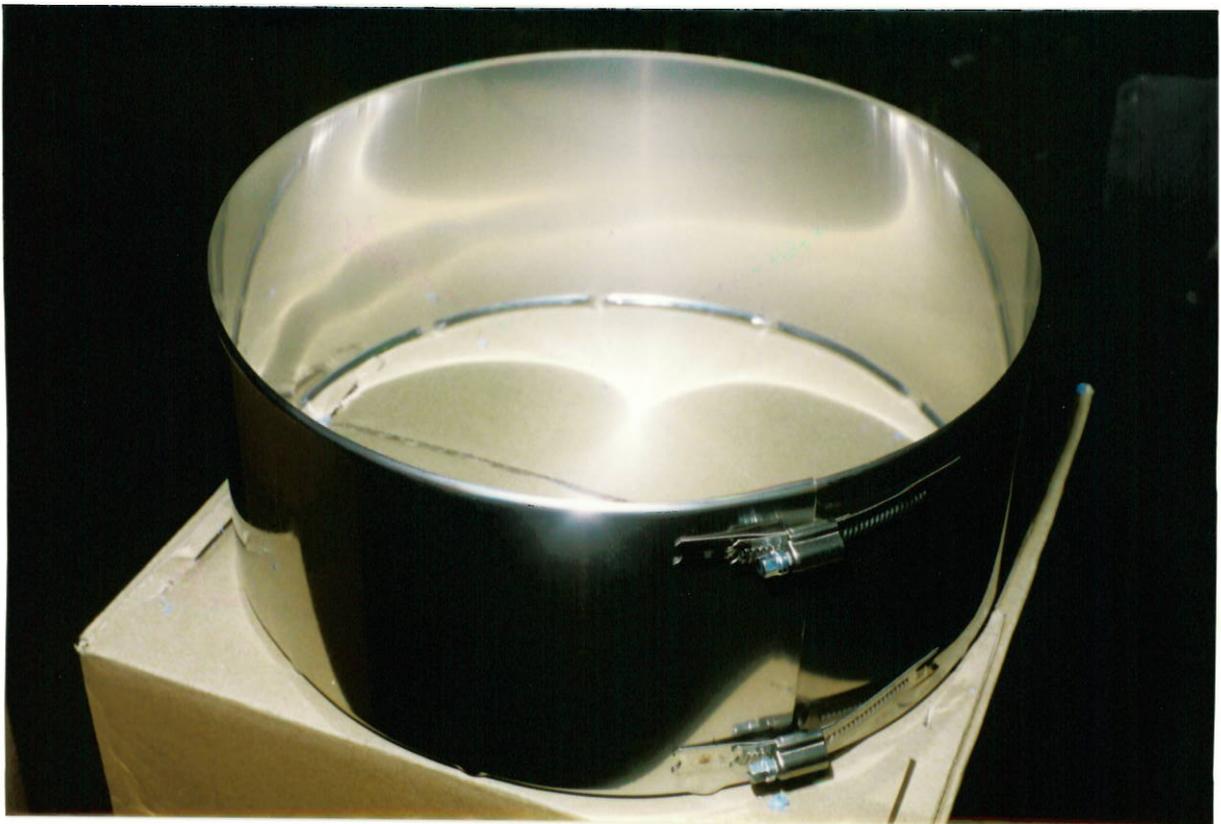
Plate 3 Metaloterm ATAB locking band

Each locking band was 120mm wide and of sufficient diameter to wrap around the outside chimney casing. They were manufactured from 0.4mm-thick stainless steel and were secured with two jubilee-clip screw fixings. A locking band is shown in Plate 3.

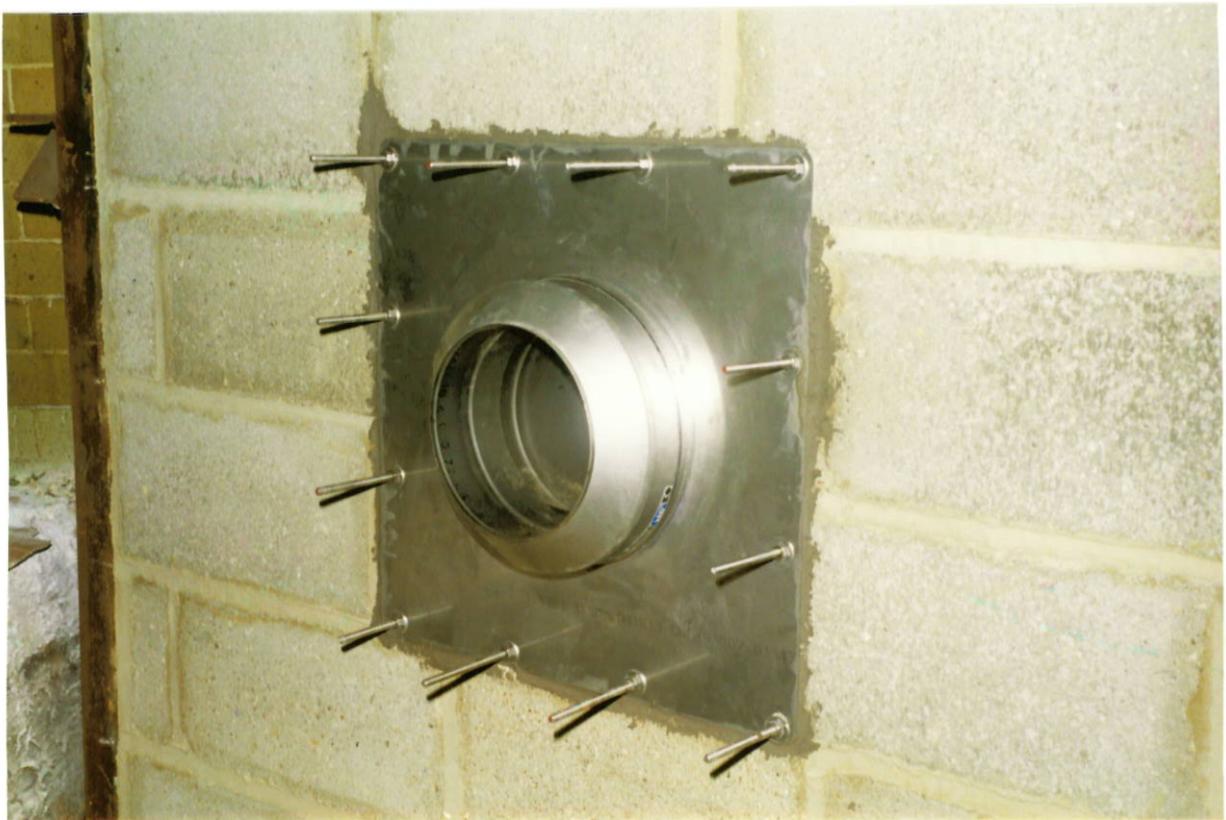
Plate 4 End of chimney inside furnace before test

The end of the chimney protruding into the furnace was finished with an ATMA top stub and is shown in Plate 4. This was a 100mm long section of chimney with the insulation capped at one end.

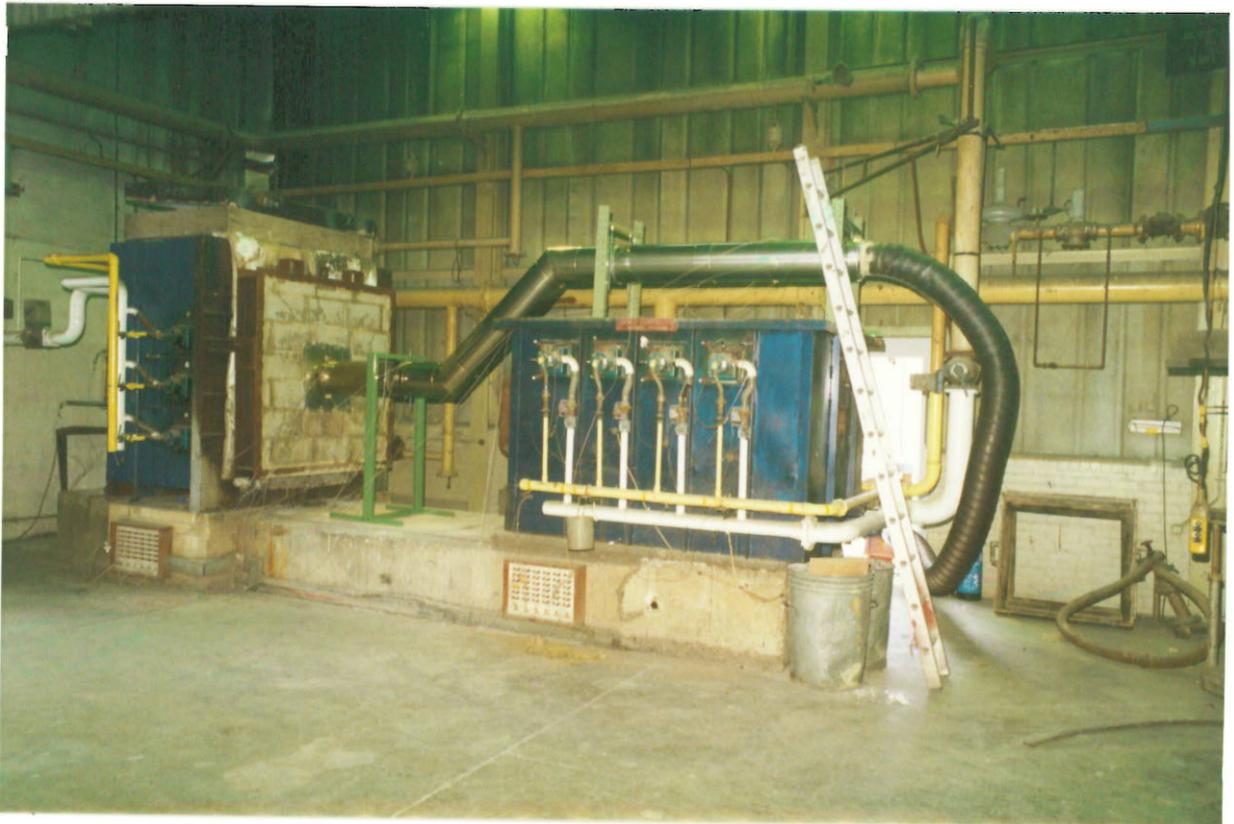
Plate 7 Chimney outside furnace after 240min test duration

Time min	Observations
0	Test started.
3	Fan switched off.
20	Wisps of steam from joints and penetration.
166	Outer casing of first section from furnace wall becoming gold coloured.
240	No further significant changes. Test terminated.

The chimney is shown after the test in Plate 7.
